# Product Change Notification

## 107598 - 00

**Change Notification #:** 107598 - 00  
**Change Title:** Intel Carrier Grade Server TIGW1U, PCN 107598-00, Product Design, Changes to AC Power Distribution Board, Fan Bracket Assembly, DVDCDR, Software Update, SAS OpROM, update PCI-X riser, update Deployment CD, add Battery Isolation.  
**Date of Publication:** Aug 01, 2007

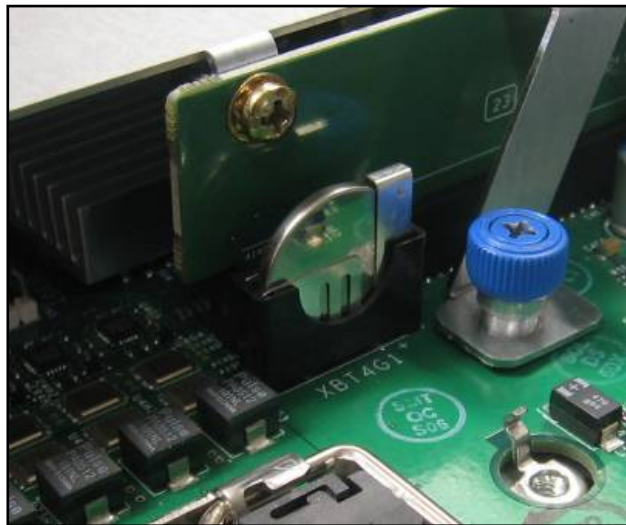
Figure 1. Battery in Relation to PCI Assembly Leg

Add battery isolator around battery. As seen in Figure 1, the PCI assembly mechanical assembly is very close to the battery. In order to reduce the chance of the PCI riser card assembly from touching the battery during removal and insertion, a battery isolator is being installed around the battery. Figure 2 shows the battery isolation in place.

3f. Add battery isolator.
