Product Change Notification

106061 - 00

Change Notification #: 106061 - 00
Change Title: IXB2800, IXB2800KAS, IXB28004XOC3, IXB28004XOC3FB, PCN 106061-00, Product Design, Design change to prevent resetting of board when switching the redundant power source on and off
Date of Publication: March 18, 2006

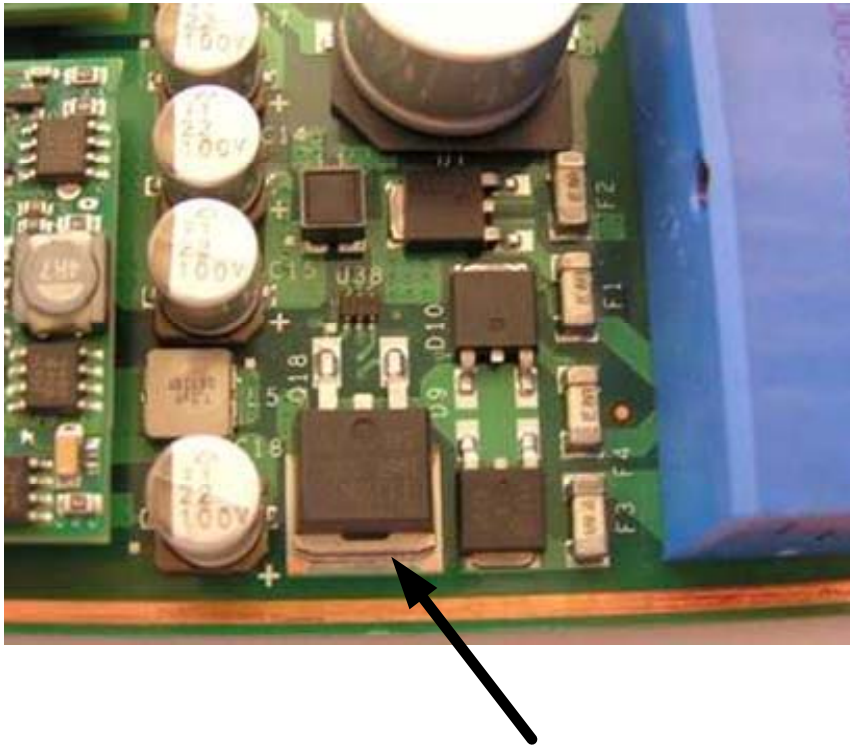
Fig.1 Q18 location on C99378-00x baseboard

To prevent resetting of the board that is operating when redundant power sources is being switched on and off requires a component change in the input protection circuit. The component to be changed is transistor Q18 located on the baseboard between the blue connector and main DC-DC converters, close to the edge of the board—see Fig.1 below.

Power MOSFET transistor Q18 is replaced with a transistor that has a much lower channel resistance. Since the board reset is initiated by the voltage drop across the channel resistance this change makes the protection circuit less sensitive to transients. This change does not affect ATCA compliance.

Intel recommends that these boards be returned to Intel for rework. You may return the boards right away, or if the board is deployed and currently functioning properly, you may elect to wait to see if the board exhibits the described symptoms. All returned boards will be repaired free of charge via Intel's Direct Return Authorization (DRA) process. The boards must be returned within the applicable warranty period to receive the free of charge repair.
