MegaCore IP Library Release Notes and Errata

MegaCore Library Version: 9.1
Document Version: 9.1.4
Document Date: 15 May 2010

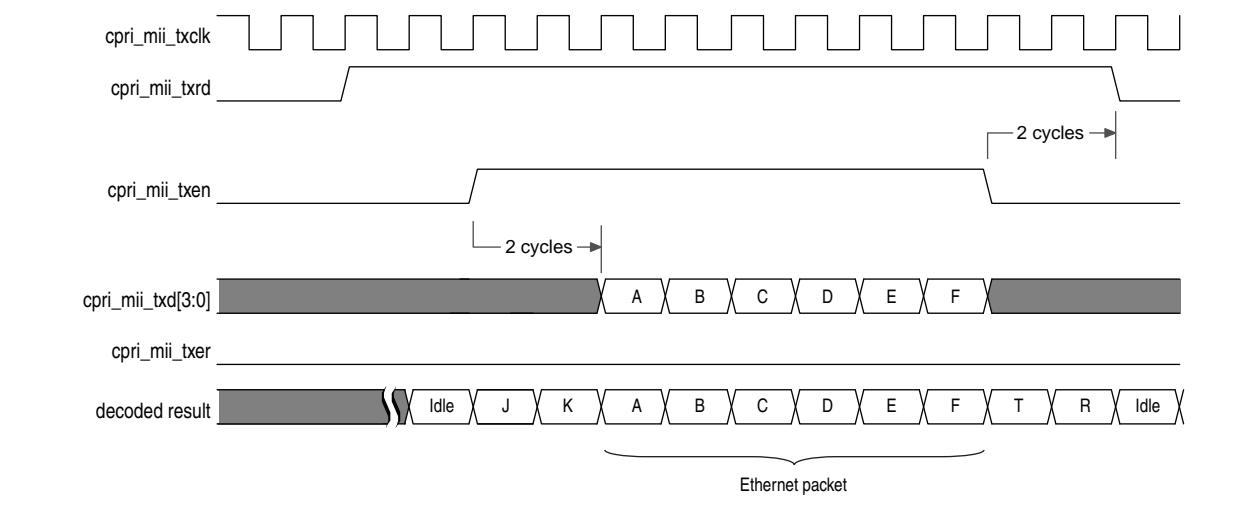
Figure 4-1. Corrected CPRI MII Interface Transmitter Example

The CPRI MegaCore Function User Guide contains erroneous information about the MII interface. Figure 4-16 and Figure 4-17 in the CPRI MegaCore Function User Guide should be replaced with the figures in this erratum.

Although [Figure 4-1](#) shows `cpri_mii_txrd` asserted continuously during transmission of an Ethernet packet on `cpri_mii_txd`, this is not always the case. The CPRI MII Interface transmitter can deassert `cpri_mii_txrd` while `cpri_mii_txen` is still asserted, to backpressure the external Ethernet block. If this happens, the Ethernet block must deassert `cpri_mii_txen` on the following cycle, to prevent the MII Interface transmitter buffer from overflowing. The `cpri_mii_txen` signal should remain deasserted until the cycle following reassertion of `cpri_mii_txrd`. If `cpri_mii_txen` is not reasserted in the cycle following the reassertion of `cpri_mii_txrd`, then an Idle cycle is inserted in the packet; therefore, the external Ethernet block must reassert `cpri_mii_txen` in the cycle following reassertion of `cpri_mii_txrd`.

Replace Figure 4-16 on page 56 of the CPRI MegaCore Function User Guide with the following [Figure 4-1](#).

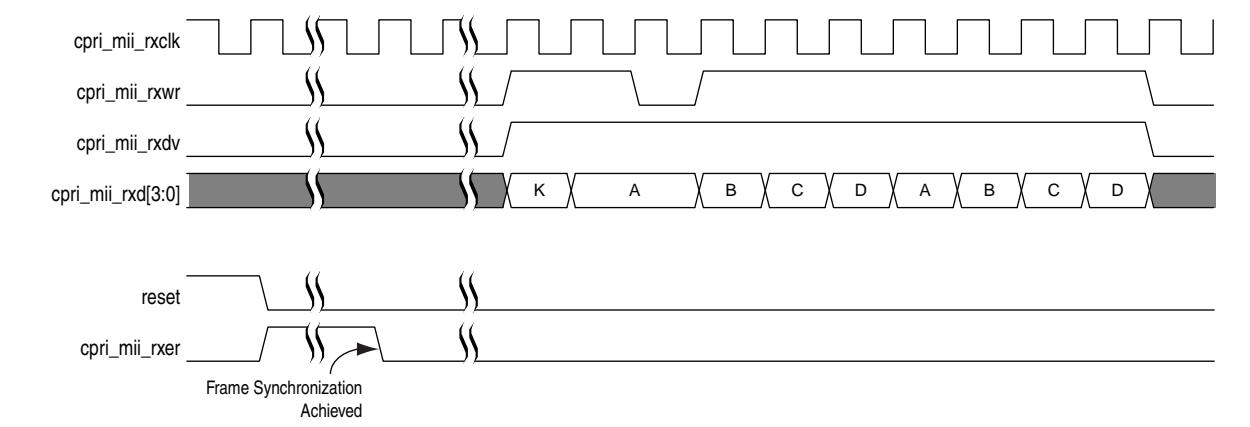
Figure 4-2. Corrected CPRI MII Interface Receiver Example

The J nibble of the start-of-frame is consumed by the CPRI MegaCore function, and is not transmitted on the MII interface.

The CPRI MII Interface receiver transmits the K nibble to indicate start-of-frame on the MII interface. Replace Figure 4-17 on page 57 of the CPRI MegaCore Function User Guide with the following [Figure 4-2](#).

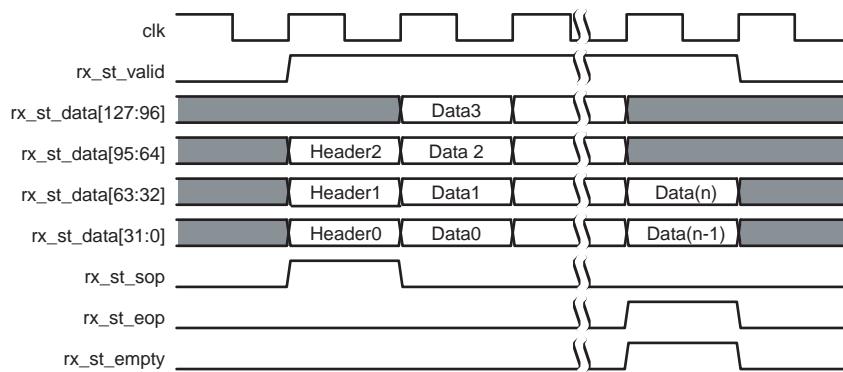
Figure 16-1. 128-Bit Avalon-ST rx_st_data0 Cycle Definition for 3-DWord Header TLPs with QWord Aligned Addresses

Figure 16-1 shows the mapping of 128-bit Avalon-ST Rx packets to PCI Express TLPs for TLPs with a three dword header and qword aligned addresses.

This is a documentation error only.

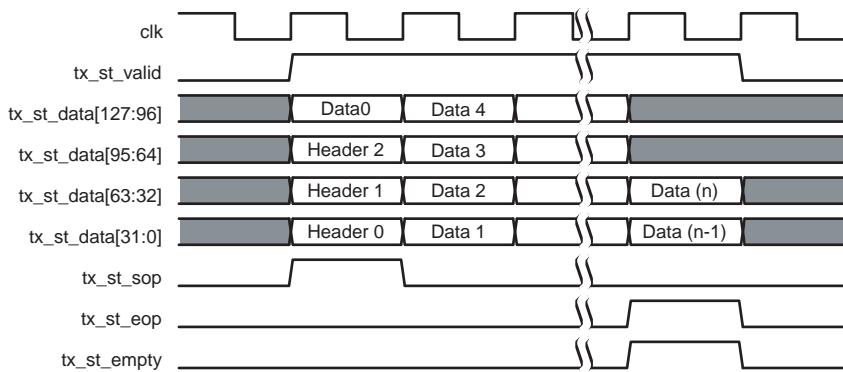
Figure 16-2. 128-Bit Avalon-ST rx_st_data0 Cycle Definition for 3-DWord Header TLPs with non-QWord Aligned Addresses

Figure 16-2 shows the mapping of 128-bit Avalon-ST Rx packets to PCI Express TLPs for TLPs with a 3 dword header and non-qword aligned addresses.

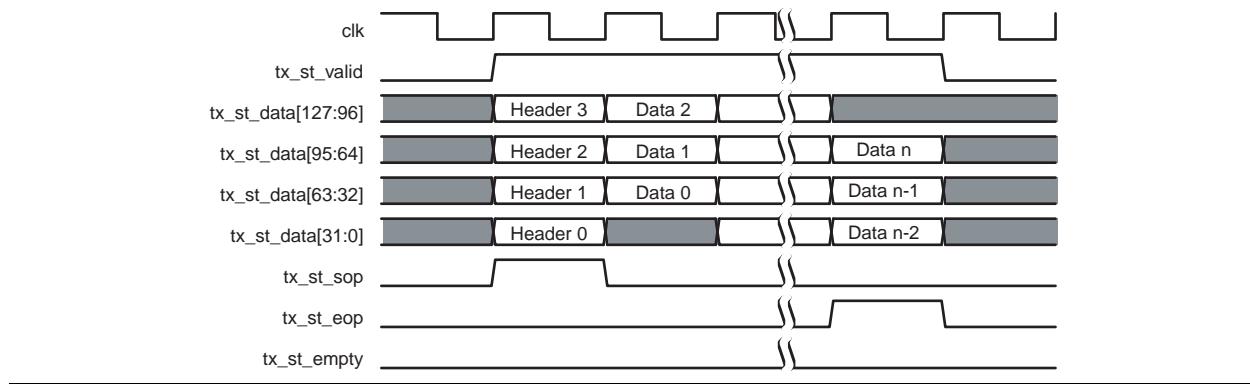
Figure 16-3. 128-Bit Avalon-ST rx_st Cycle Definition for 4-DWord Header TLPs with non-QWord Aligned Addresses

Figure 16-3 shows the mapping of 128-bit Avalon-ST Rx packets to PCI Express TLPs for a four dword header with non-qword aligned addresses. In this example, rx_st_empty is low because the data ends in the upper 64 bits of rx_st_data.

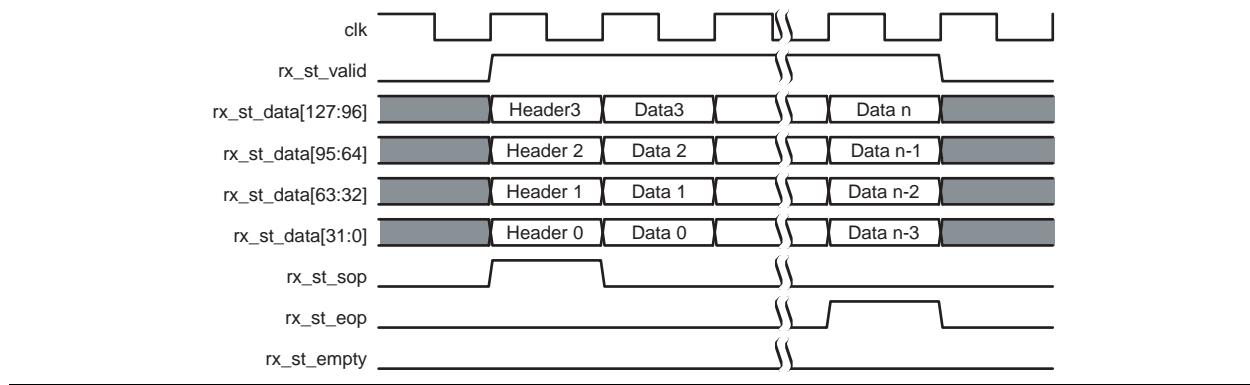
Figure 16-4. 128-Bit Avalon-ST rx_st Cycle Definition for 4-DWord Header TLPs with QWord Aligned Addresses

Figure 16-4 shows the mapping of 128-bit Avalon-ST Rx packets to PCI Express TLPs for a four dword header with qword aligned addresses.

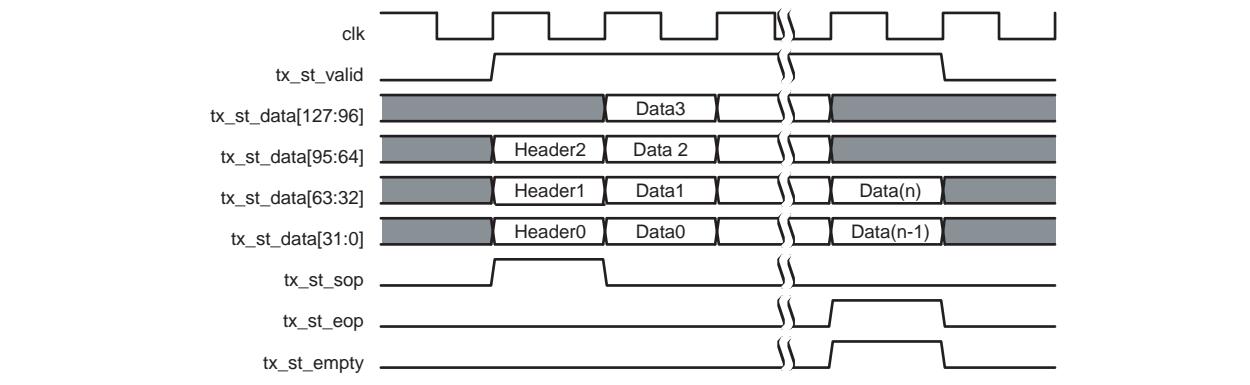
Figure 16-5. 128-Bit Avalon-ST tx_st_data Cycle Definition for 3-DWord Header TLPs with QWord Aligned Addresses

Figure 16-5 shows the mapping of 128-bit Avalon-ST Tx packets to PCI Express TLPs for a three dword header with qword aligned addresses.

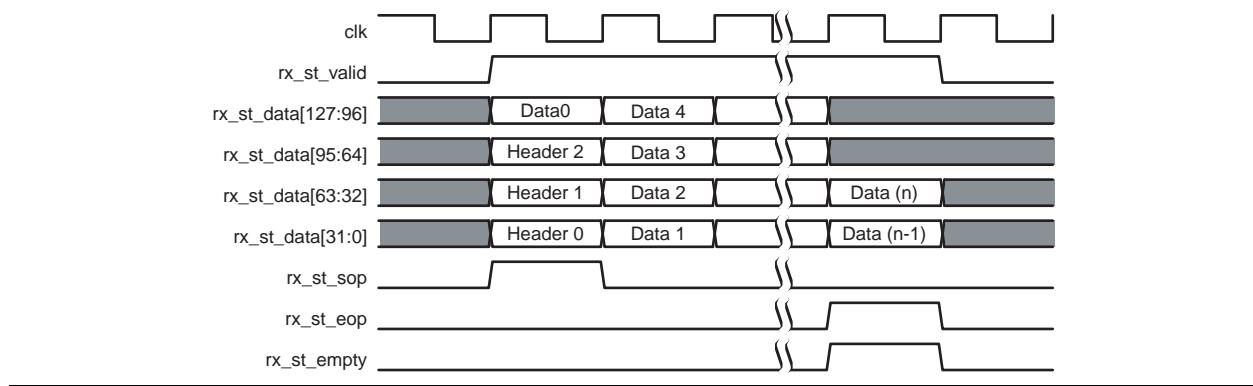
Figure 16-6. 128-Bit Avalon-ST tx_st_data Cycle Definition for 3-DWord Header TLPs with non-QWord Aligned Addresses

Figure 16-6 shows the mapping of 128-bit Avalon-ST Tx packets to PCI Express TLPs for a 3 dword header with non-qword aligned addresses.

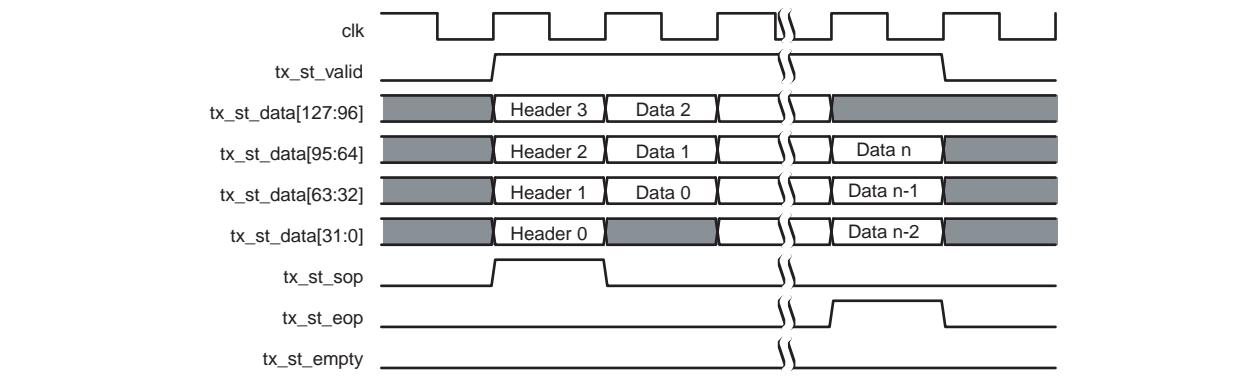
Figure 16-7. 128-Bit Avalon-ST tx_st_data Cycle Definition for 4-DWord Header TLPs with non-QWord Aligned Addresses

Figure 16-7 shows the mapping of 128-bit Avalon-ST Tx packets to PCI Express TLPs for a four dword header TLP with non-qword aligned addresses. In this example, `tx_st_empty` is low because the data ends in the upper 64 bits of `tx_st_data`.

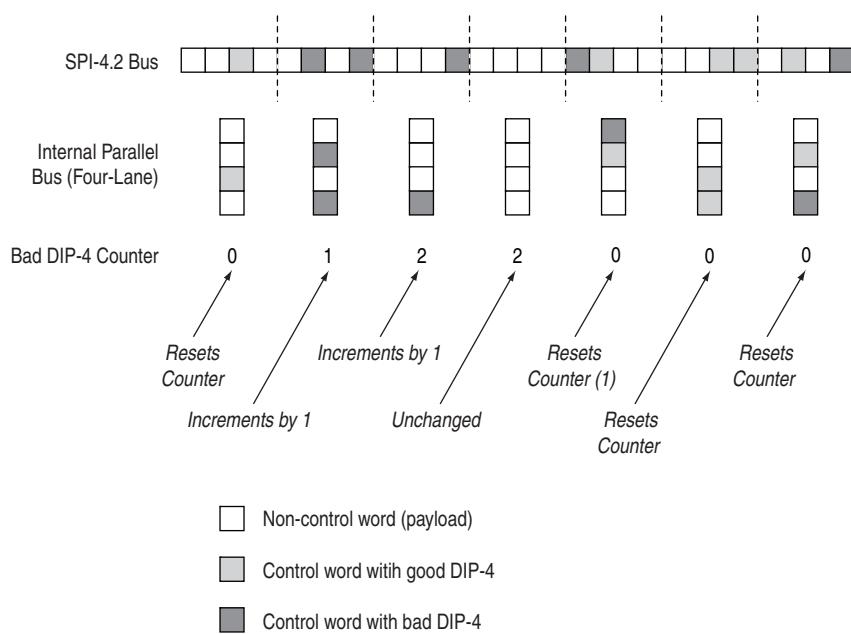
Figure 18-1. DIP-4 Counter *(Note 1)*

[Figure 18-1](#) shows an example of the DIP-4 counter, where the receiver is in service state and bad threshold is 3.

(1) Receiving a good and a bad DIP-4 in the same parallel cycle resets the counter (does not increment it), so that OOS does not trigger.
