# Intel® Quark™ SoC X1000

## Specification Update

*February 2015*

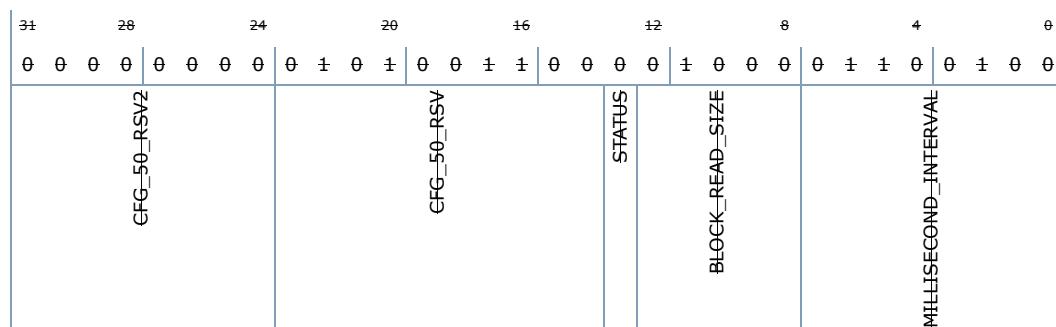
Bit-Range	Default & Access	Field Name (ID): Description
31:24	00h R0	<b>Reserved (CFG_50_RSV2):</b> Reserved.
23:14	14Ch RW	<b>Reserved (CFG_50_RSV):</b> Reserved.
13	0b RW	<b>Status (STATUS):</b> Indicates if ECC scrubbing is active or inactive. 0b : Scrubbing Inactive 1b : Scrubbing Active
12:8	08h RW	<b>Block Read Size (BLOCK_READ_SIZE):</b> Block read size in DWORDs (4 bytes). Range 1 to 128 (4-512 bytes).
7:0	64h RW	<b>Millisecond Interval (MILLISECOND_INTERVAL):</b> Millisecond interval between block reads. Range 1-255 msec.

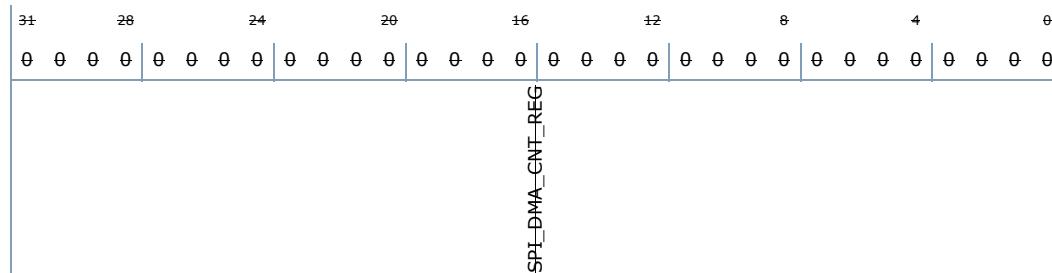
Bit-Range	Default & Access	Field-Name (ID): Description
31:0	0b RW	<b>SPI DMA Count (SPI_DMA_CNT_REG):</b> Count of 512 byte block transfers. Writing this register triggers the start of the transfer of the indicated number of blocks. Reading this register returns the number of blocks that are remaining to be transferred. A value of 0 indicates the transfer is complete.

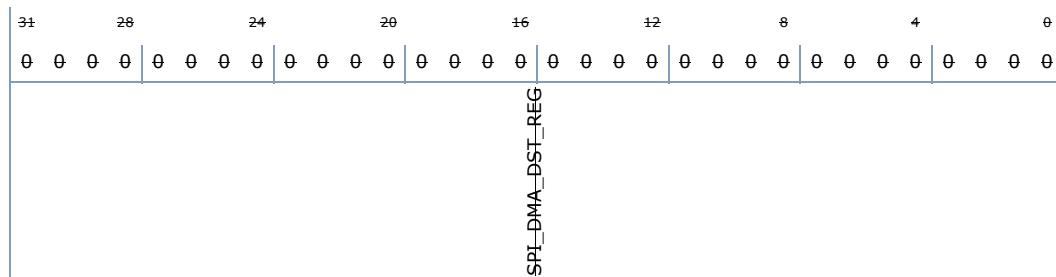
## 12.6.2.2 SPI DMA Destination Register (SPI\_DMA\_DST\_IOSF) — Offset 4h

Bit-Range	Default & Access	Field Name (ID): Description
31:0	00000000h WO	<b>SPI-DMA Destination (SPI_DMA_DST_REG):</b> 32-bit Destination Address of data in System Memory (eSRAM/DRAM).

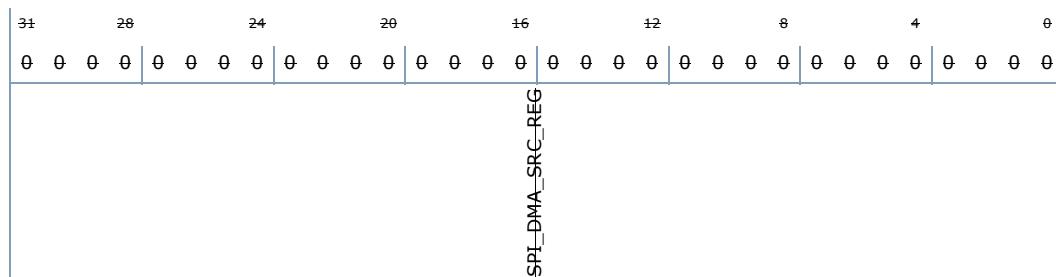
## 12.6.2.3 SPI DMA Source Register (SPI\_DMA\_SRC\_IOSF) — Offset 8h

Bit-Range	Default & Access	Field Name (ID): Description
31:0	00000000h WO	<b>SPI-DMA Source (SPI_DMA_SRC_REG):</b> 32-bit Source Address of data in Legacy SPI.

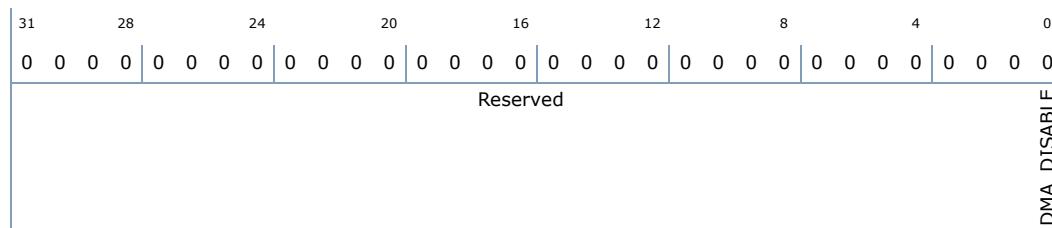
Bit Range	Default & Access	Field Name (ID): Description
31:1	0 RO	Reserved (RSVD): Reserved.
0	0 RW	DMA_DISABLE: Remote Management Unit DMA disable. Once set RMU DMA functionality is disabled until system reset
