Enhanced Downstream Port Containment Enablement for Hot-Plug

Deploying a successful use case using Tencent on Intel Enhanced Downstream Port Containment Enablement technology to handle PCI Express* Hot-Plug

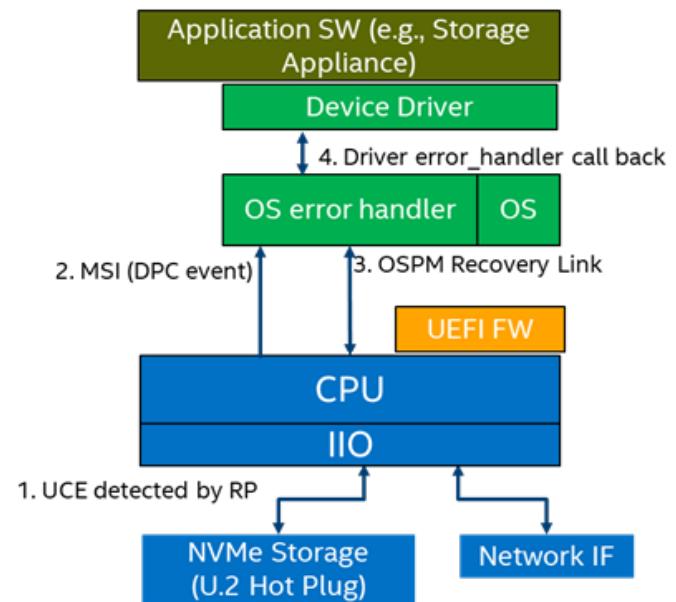
Figure 1-1. EDPC aware Native OS (Linux*) Mode

Boot time:

1. UEFI FW optionally enables EDPC prior to handing over control to OS.
2. Operating System Power Management (OSPM) requests and gets control of EDPC, Advanced Error Report (AER), and hot-plug.
3. OSPM initializes AER, DPC, and hot-plug registers. Enables EDPC interrupt.

Run time:

1. Uncorrected error detected by RP (for example, Malformed TLP). SW triggered DPC could also be used for validation purpose.
2. RP sends Message Signal Interrupt (MSI) to OS Error Handler. OS handler detects DPC event. DPC Status and Error Source ID are logged; RP PIO status is logged if applicable.
3. If port implements DPC capabilities, OSPM will attempt recovery by releasing the link from DPC, link retraining and active, or restore child devices to working state.
4. OSPM notifies drivers of child devices of port, the pci_driver via pci_driver's.err_handler callback: error_detected, slot_reset, error_resume.

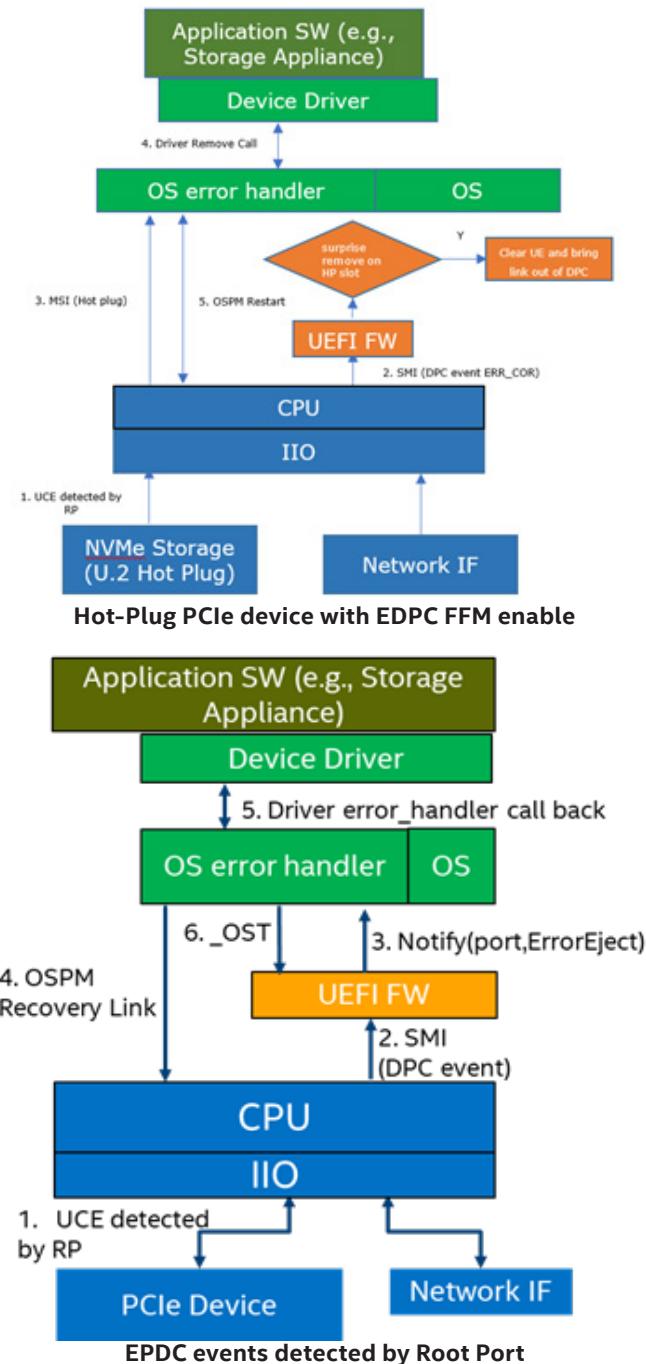
Figure 1-2. Firmware First Mode (FFM) with EDPC aware OS

Boot time:

1. UEFI FW may initialize EDPC registers or leave them disabled.
2. OSPM requests ownership of EDPC+ AER+ hot-plug. FW grants ownership of hot-plug and keeps ownership of AER and EDPC.
3. OSPM does not initialize AER and EDPC. It sets up hot-plug registers. Enables EDPC interrupt. FW may enable EDPC once it receives a hint from OSPM via _DSM.
